## Effects of Poor Drainage System to Built Environment: A Case Study of Auchi Metropolis

### Abstract

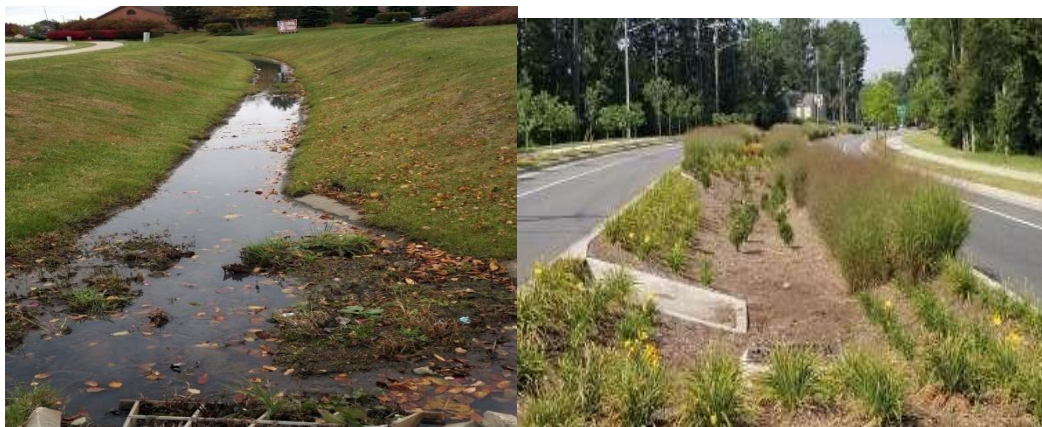
**Fig 1: A Natural drainage ditch (SOURCE: Aquabrightllc.comSource: [www.google.com](http://www.google.com).)**

**Natural Drainage:** In this method excess water flows from the fields to swamps or lakes, however, this is often inadequate and therefore artificial or man – made drainage will be required as support. (Smith, 2016).

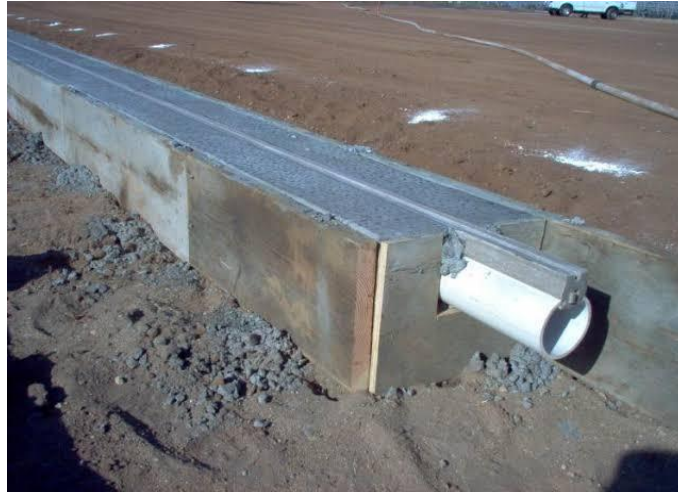
**Fig 3. A Slot Drain System (Source: sportsedge.com)**

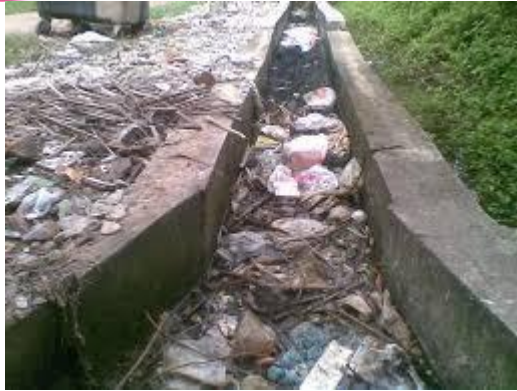
Fig 4 (a) **Blocked Drains**

After heavy rain or storms, drains outdoors are usually blocked by the leaves, cellophane bags, broken plastics and other debris/dirt. These drains are not made to manage large volumes of water. Therefore, this may lead to flooding outside the property as shown below in Plate 5(a-b)

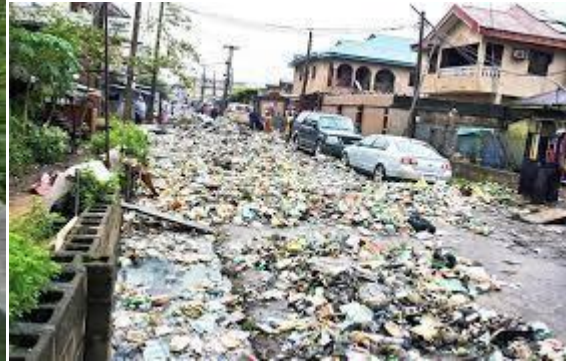
Fig 4b: **Flooded road in Lagos**

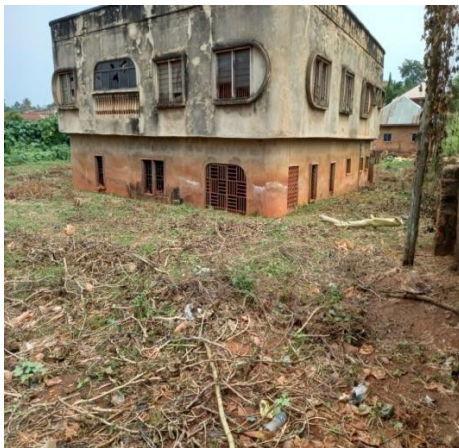
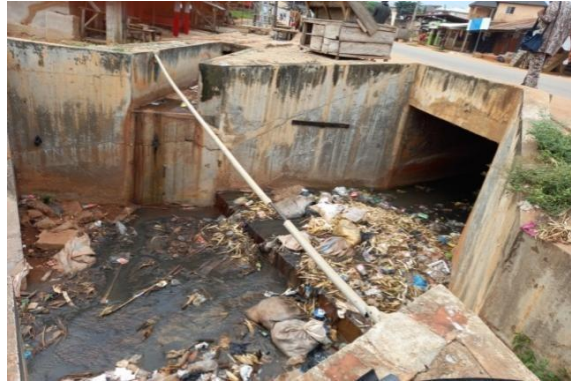
Fig 4c: **Submerge Building in flood**

**Refuse****Dump in drains****Along Solo Street in Auchi****Along Iyekhe Street in Auchi**

**4. Indiscriminate Waste Disposal:** Some residents regularly dump waste in gutters, along the road and in market places, so whenever it rains it is common to see flooded streets with these waste, litters, floating everywhere. This often leads to unsanitary conditions which contribute to the degradation of the environment and risk to the building industry.

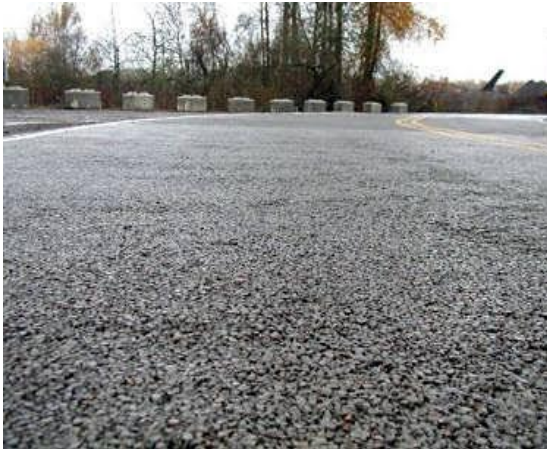
**Fig 5: Permeable Concrete**  
(Source: roohome.com)

- Use of rain barrels, Polyethylene Cistern, building of Permeable Pavement, Permeable Concrete, Interlocking Concrete Pavement should be encouraged in premises.

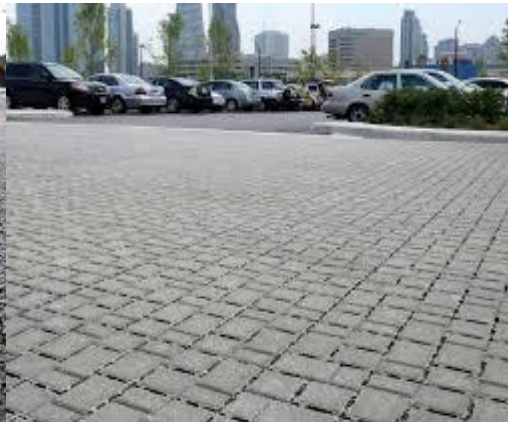
**Fig 6 Interlocking concrete**  
(Source: 3driverswetweather.org)

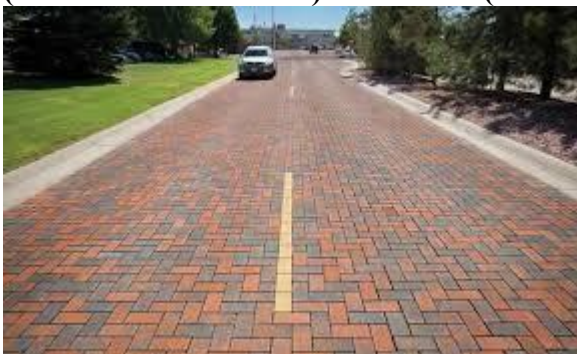
**Fig 7: Sustainable Design Road**

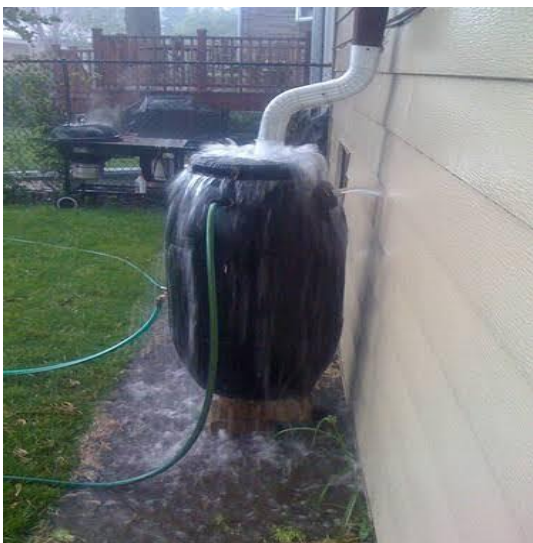
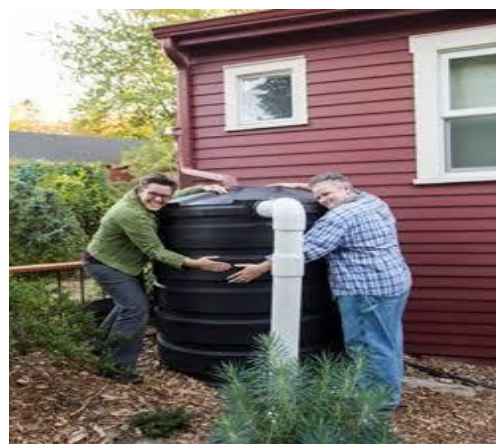
**Fig 8: Rain Barrels**

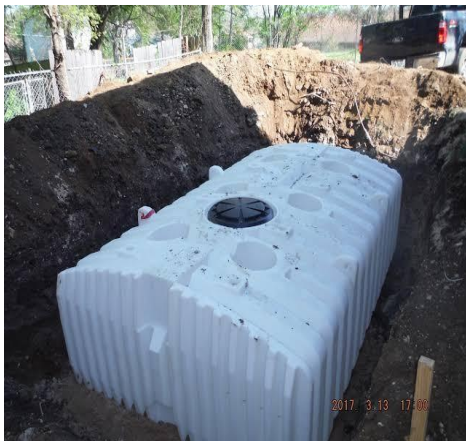
**Fig 9: Underground Polyethylene Cistern**

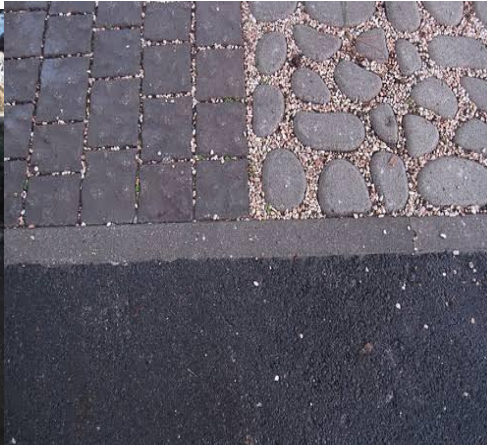
**Fig 10: Permeable Pavement**
